Ultraflex4x4 Correction Bulletin 001

Date: 20180201 Ultraflex4x4.com.au

Product: UF-9027 (Pat. Pend.)

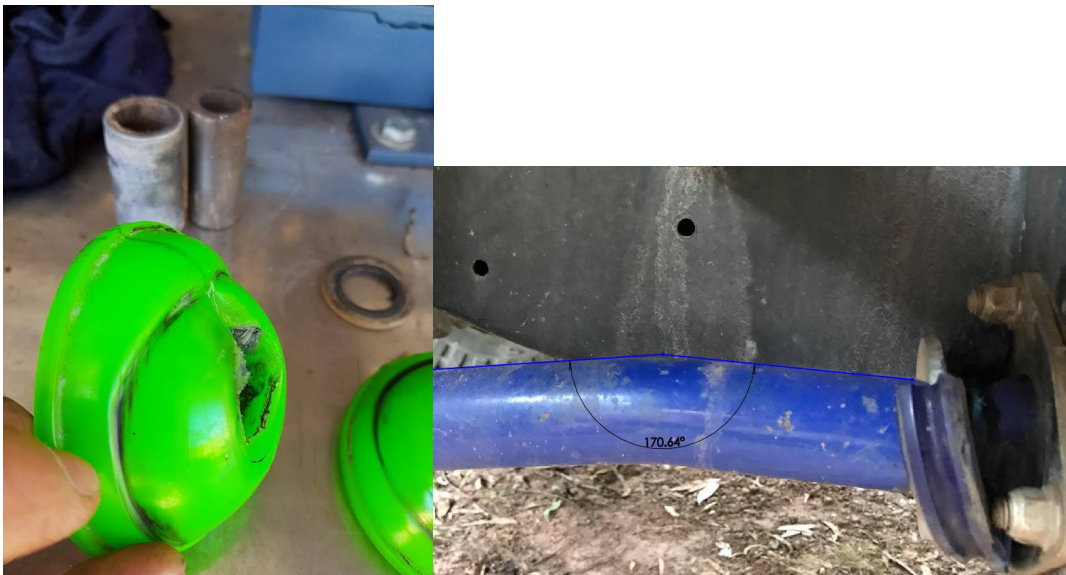
In all cases, the opposition bushing failed in a manner that was dangerous, however the Ultraflex4x4 bush also failed in a way that caused distortion and some tearing. Below is the worst case for the Ultraflex4x4 Bushing (Left) . The Superpro Shown on right. The Arm is a Gwen Lewis 10 Degree Cranked.

1./ It was establish that the damage to the bushes was due to the offset force applied by the use of cranked arms. The force vector from the centre of the diff mount bolt to the centre of the chassis mount was not axial to the designed operation of all bushings.

3./ In the case of the Ultraflex4x4 bushing, the offset force applied caused the bushes to "walk" across the rear face. This was due to the force being applied to the cut lip on the washer, and the washer being tilted by the arm crank angle as showing in the SuperPro Picture.

The method of correcting the bush "walking" and the distortion, is to use a 7-8 mm thick plate with a 3mm recess that covers the outer flange when inserted. The diameter of the recess is 76mm OD and the through hole is 50mm ID in the triangle plate. Alternatively two 4 mm plates can be used, one with a 76mm hole, and one with a 50mm hole. the recessed side is towards the rear. The recessed plate also lowers the pre-load on the bushing.

The contact areas on the rear and optionally the front should be prepared using 80-200 grit wet and dry paper. This burnishing should include the PU bush and the plate in the 50-76mm diameter range. The epoxy needs to be applied, aligned in the vehicle and then installed while curing.
